FIELD EVALUATION OF GRAVITY-FED SURFACE DRIP IRRIGATION SYSTEMS IN A SLOPED GREENHOUSE

ABSTRACT

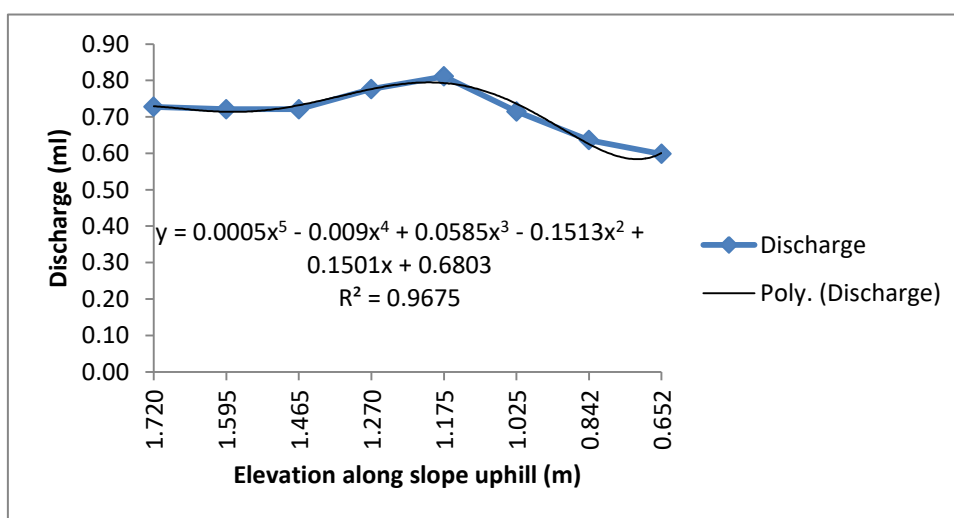
Figure 3.2 The plot of relationship between emitter discharge and site elevation

The variation in emitter discharge in relation to the flow direction and land elevation is shown in Table 3.4 and plotted in Figure 3.2. The discharge increases from the center line of the screen house which is at a distance of 11 m downhill and decreases uphill. This is purely a topographically induced occurrence and agrees with the findings of [26] and [27], in which Emission uniformity (EU) decreases drastically as the land slope increases from 0 to 4%. The decline is more pronounced when the slope increases in an upward direction where the bucket is placed on the lower side and the water flows up the slope.

The emitter discharge variation mainly depends on pressure differences owing to difference in operation head. Other significant factors affecting emitter discharge include water temperature, quality with which the emitter is manufactured [28].

Emission uniformity (EU) decreases slightly up the slope this was with [13] who reported that the coefficient of uniformity (CU) and the distribution uniformity (EU) generally increase with increasing heads and decrease with increasing slope uphill.

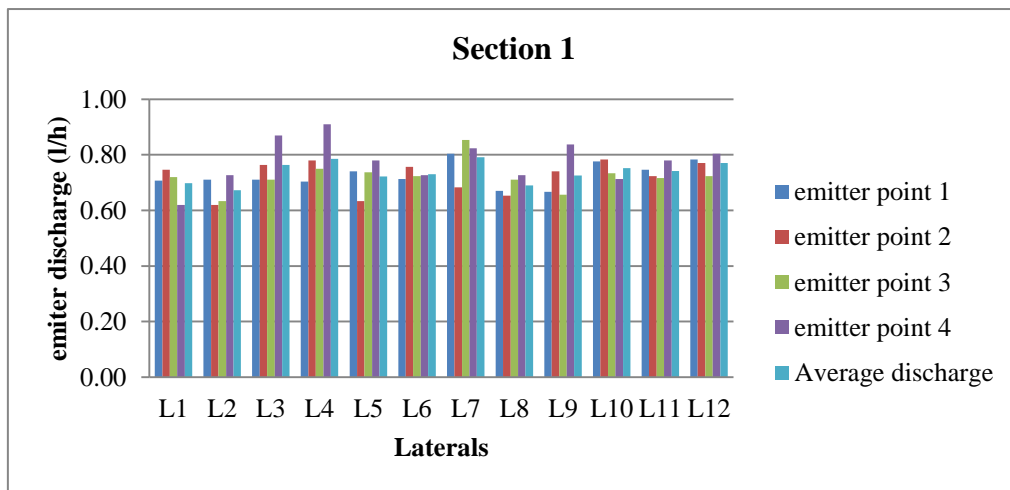
Figure 3.3 Discharge variation at various points on the laterals for section 1 (downhill flow)

The discharge variation at various points on the laterals for section 1 and 2 are shown in Figure 3.3 and 3.4 respectively.
